YOUR Inspection Report

201 NASA Parkway. Fellowship Hall
Webster, TX 77598

Tuesday, November 15, 2016

Report No. 1090

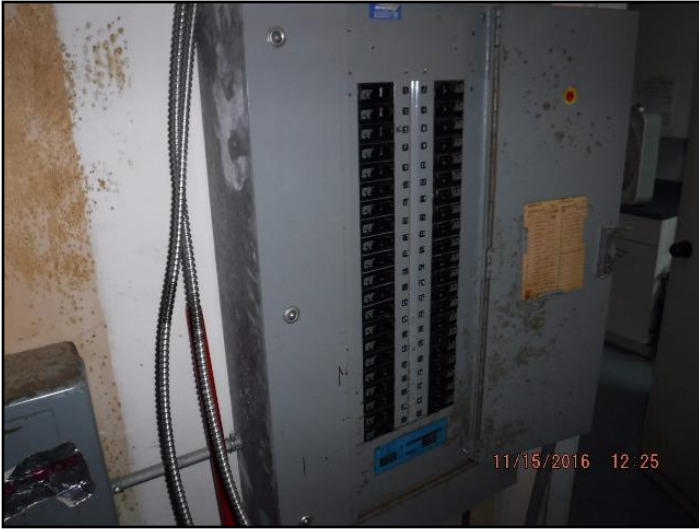
1. **Condition:** • Minor deficiencies noted

Not all breakers are labeled, some wires on the neutral bus bar are double-lugged.

2. Minor deficiencies noted-missing labels

Task: Remedy as needed

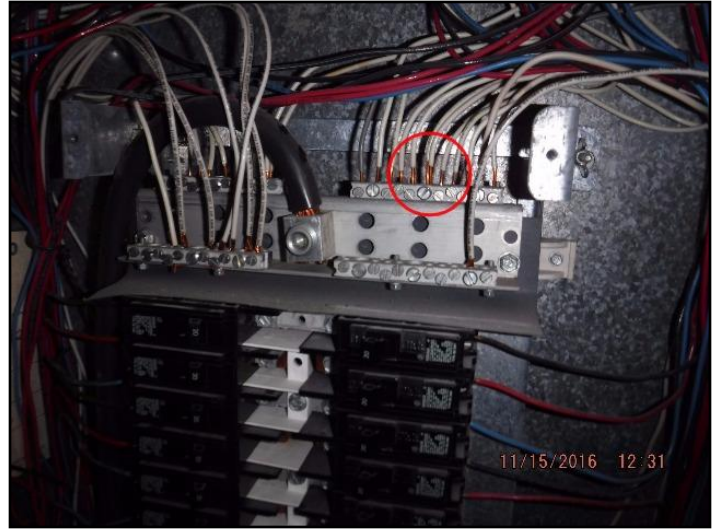
3. Minor deficiencies noted-some wires...

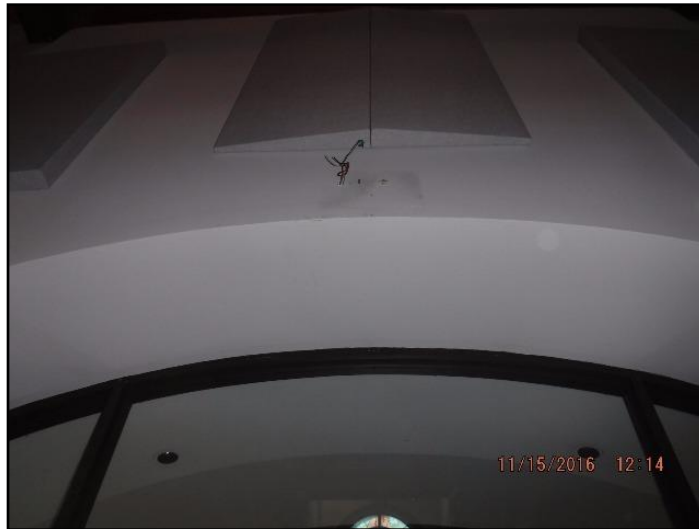
2. Condition: • Minor deficiencies noted

Missing Exit sign over main entrance into Fellowship Hall

4. Minor deficiencies noted

Task: Repair or replace

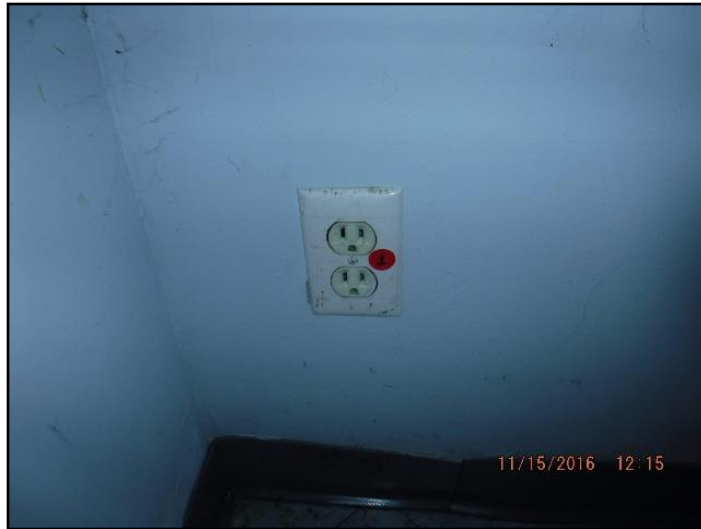
3. Condition: • Minor deficiencies noted - Broken blade in outlet near mechanical room

5. *Broken blade in outlet near mechanical room*

Task: Repair

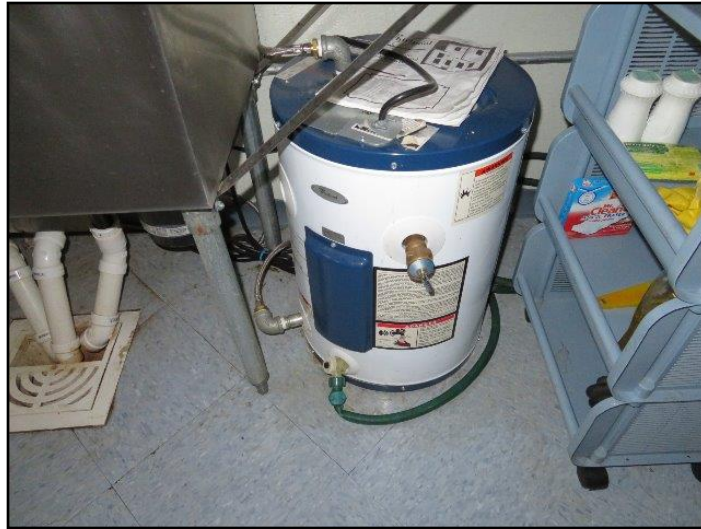
12. Over 15 yrs old

4. Condition: • Beyond its expected useful life

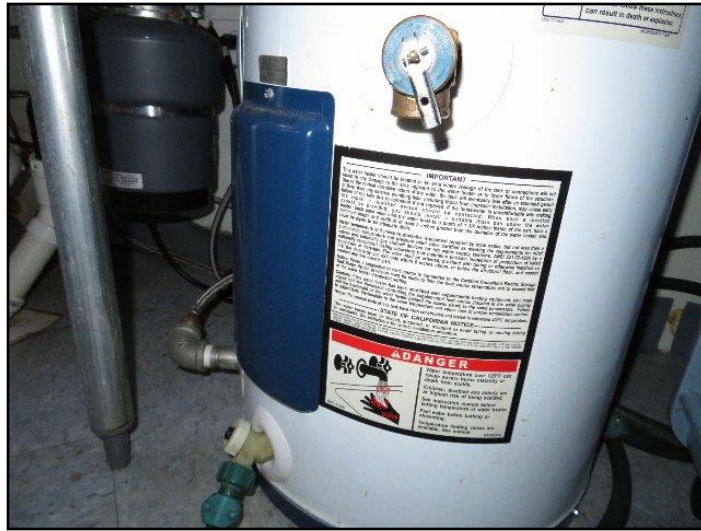
5. Condition: • Missing discharge from the pressure relief valve
TRP valve drain line is missing.

13. Missing discharge from the pressure relief...

Task: Remedy as needed to prevent burns from steam and hot water.

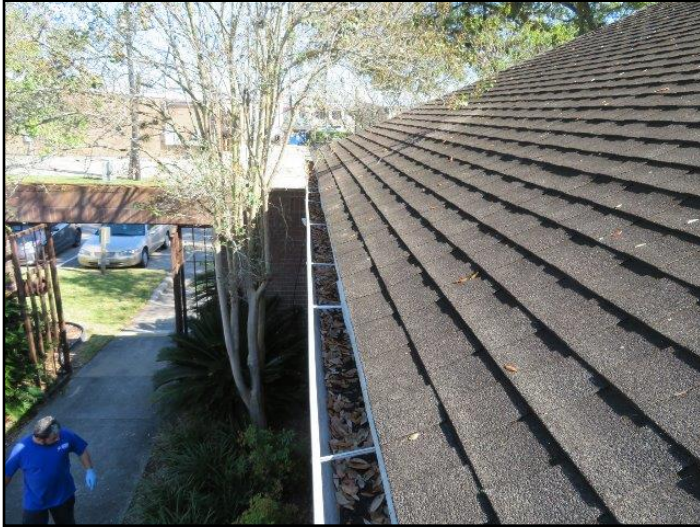
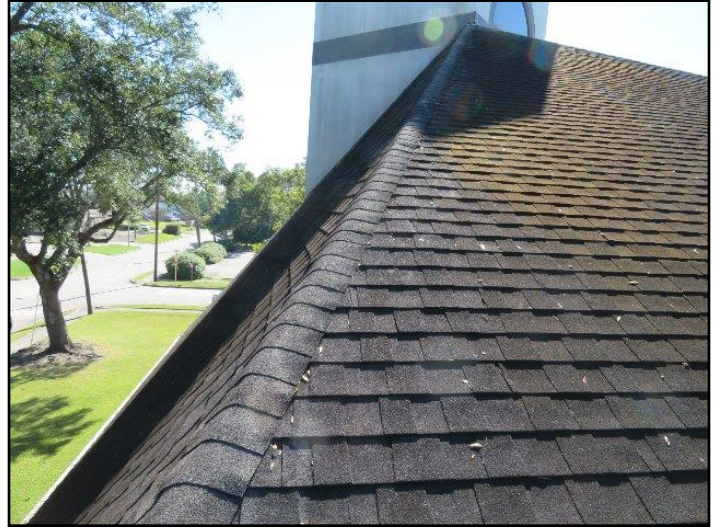
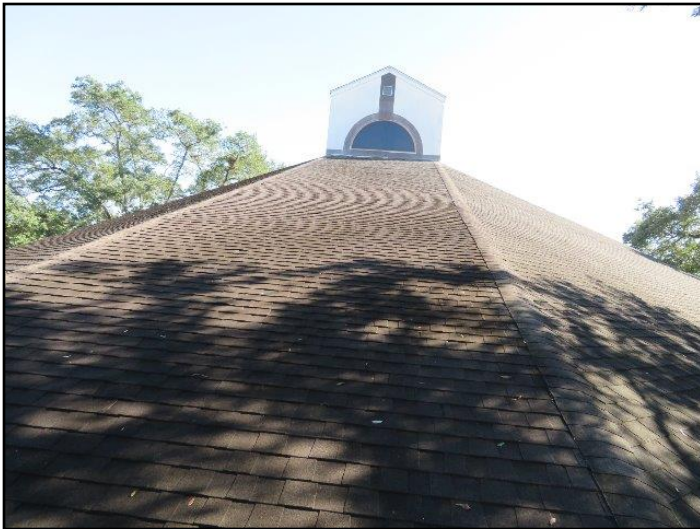
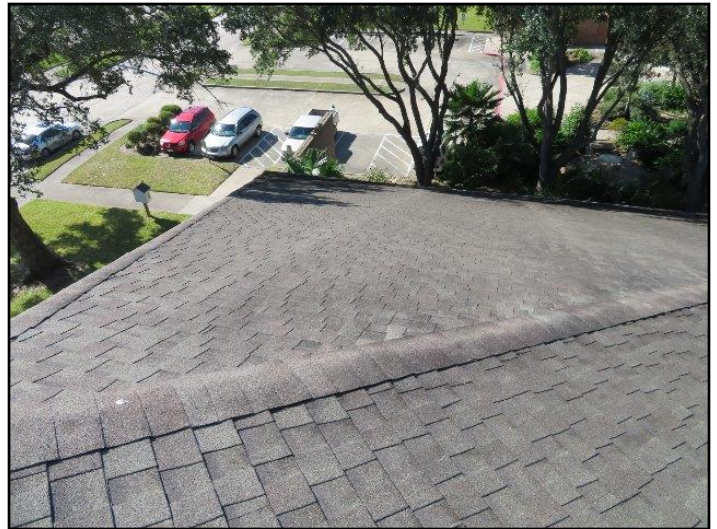
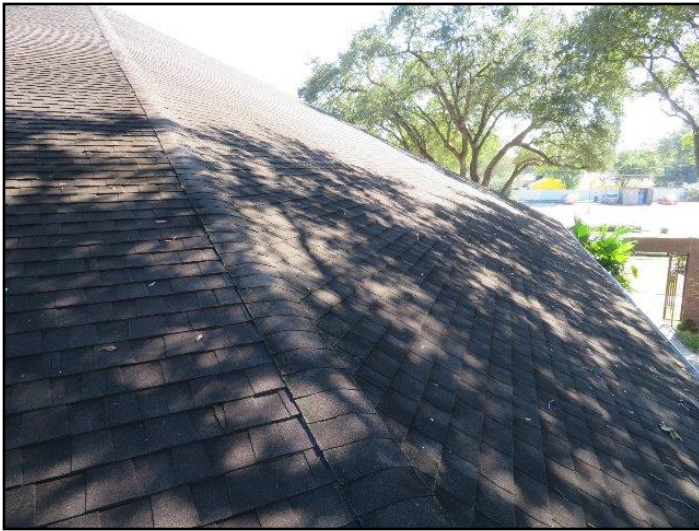
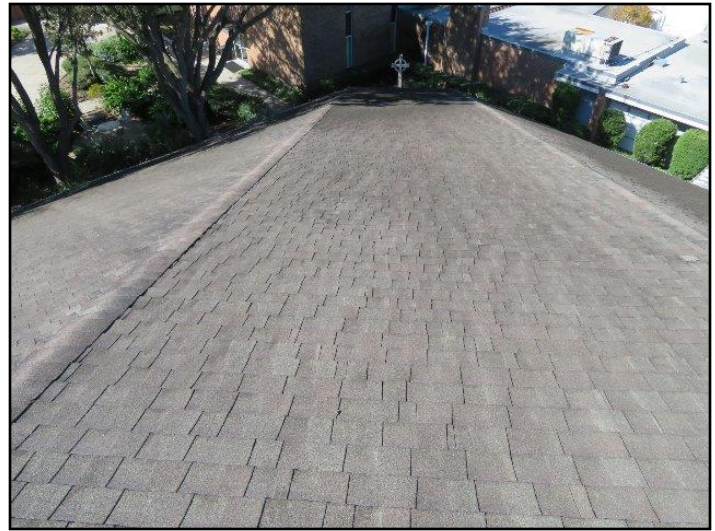
7. Condition: • Beyond typical life expectancy

Roof system is missing shingles and is well past usable life.

Cost: \$35,000 - \$38,000

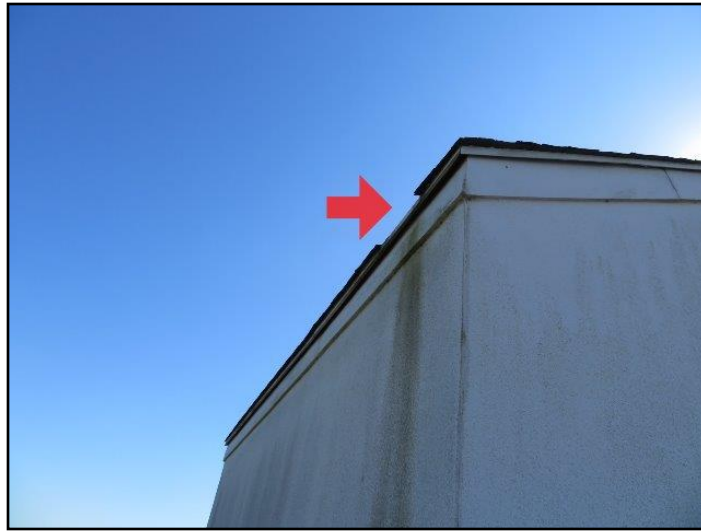
Damaged shingles along edge of small upper roof.

20. *Damaged*

Task: Evaluate and remedy as needed.

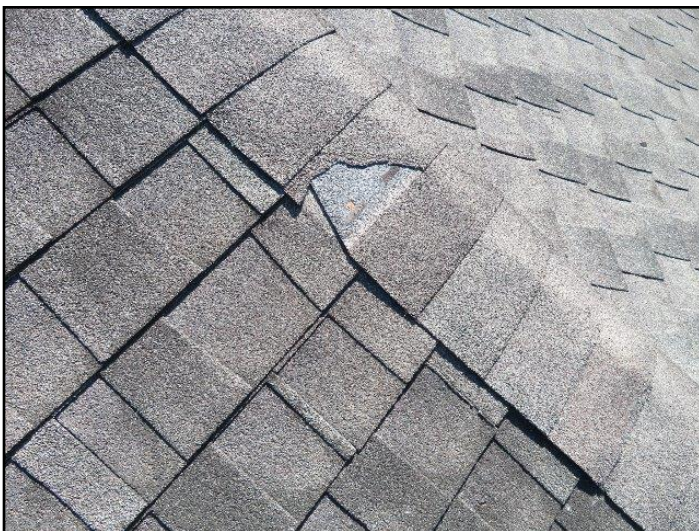
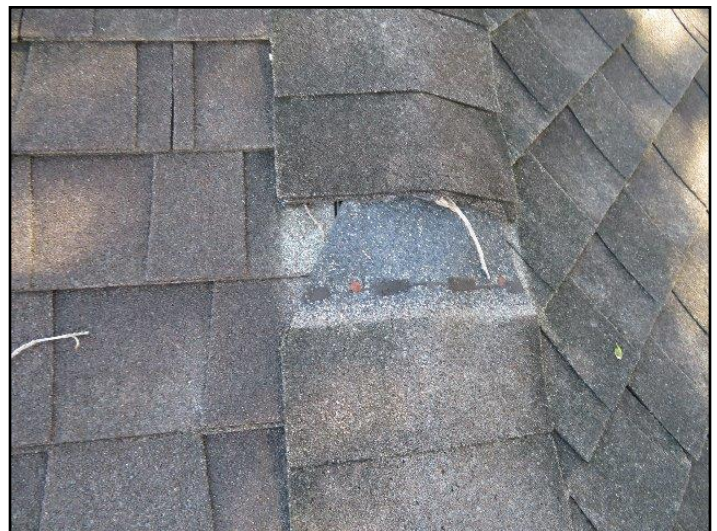
Missing ridge shingles at both back lower hips.

21. *Missing*

Task: Repair as needed to stop leaking into main lobby area.

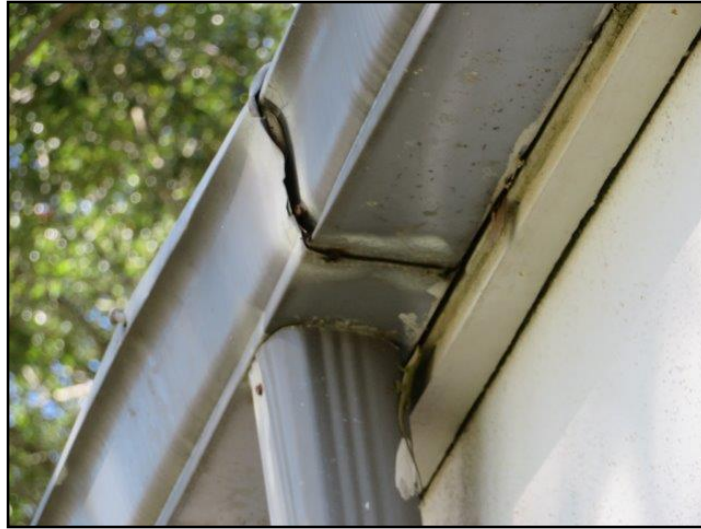
10. Condition: • Evidence of leakage noted

23. Evidence of leakage noted

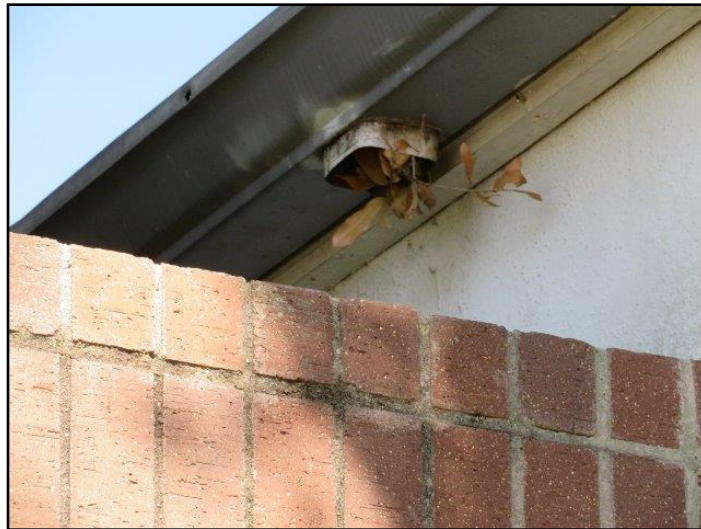
11. Condition: • Missing
Missing downspout.

Location: Back right corner of building.

24. Missing

Task: Remedy as needed.

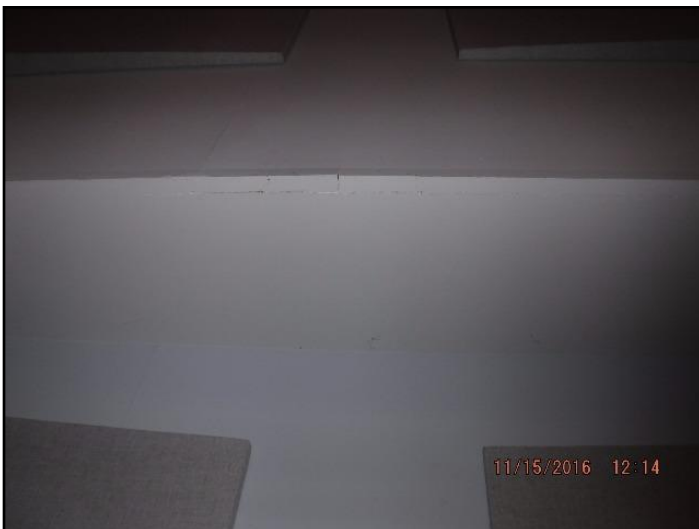
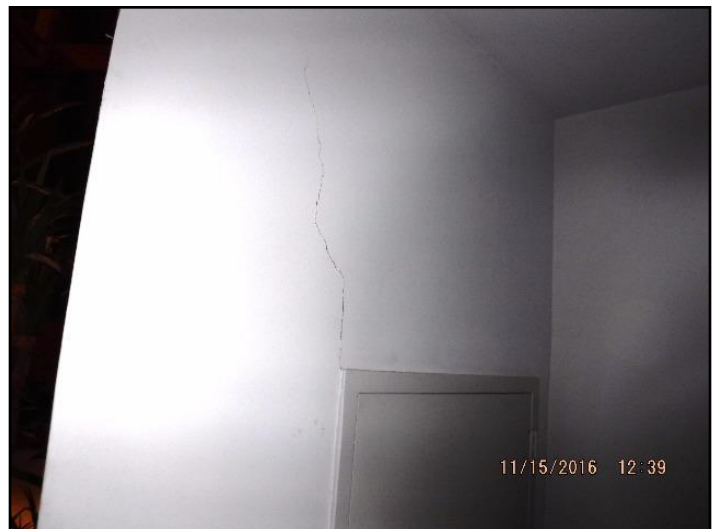
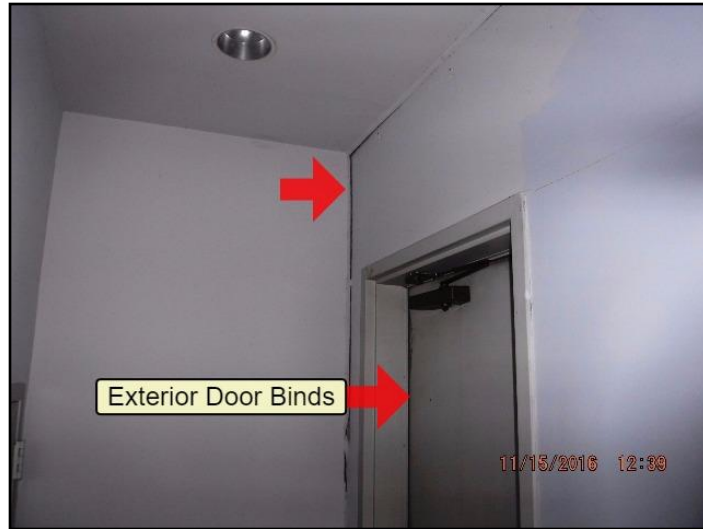
12. Condition: • Cracked/Separated drywall and doors out of square are consistent with building settlement.

Location: Main Fellowship Hall

25. Cracked/Separated drywall and doors

Task: Further evaluation

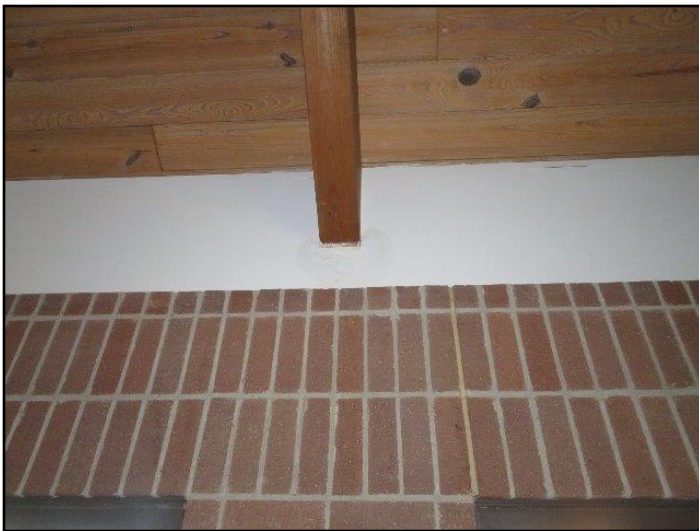
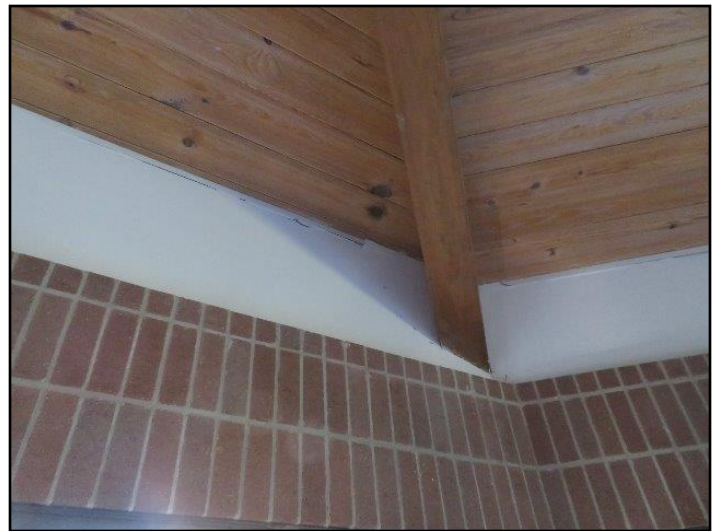
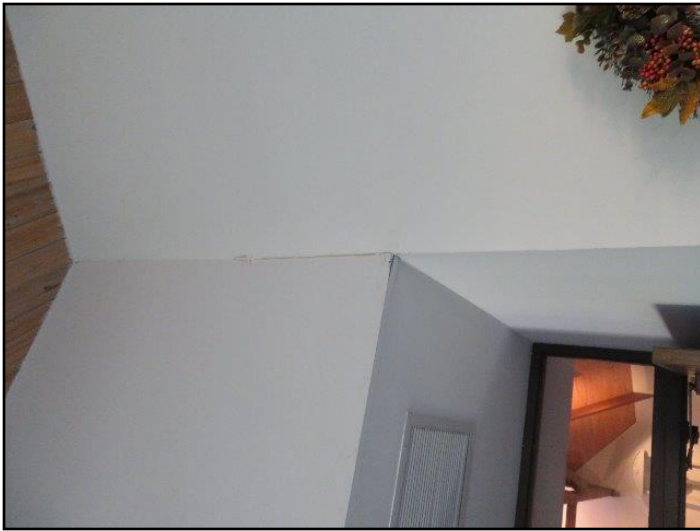
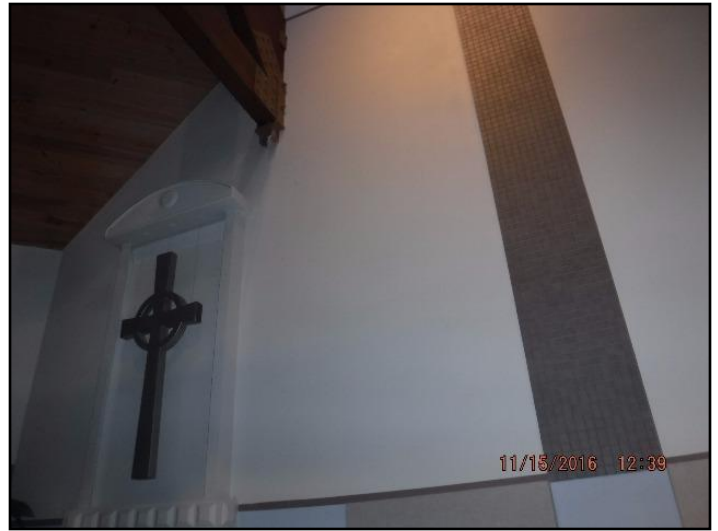
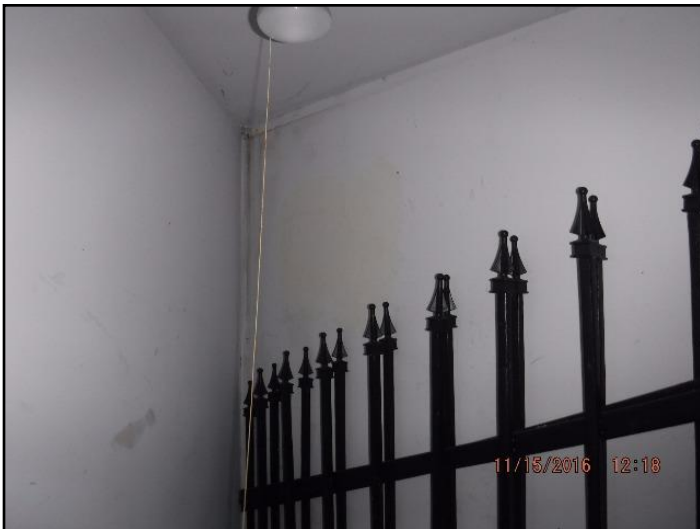
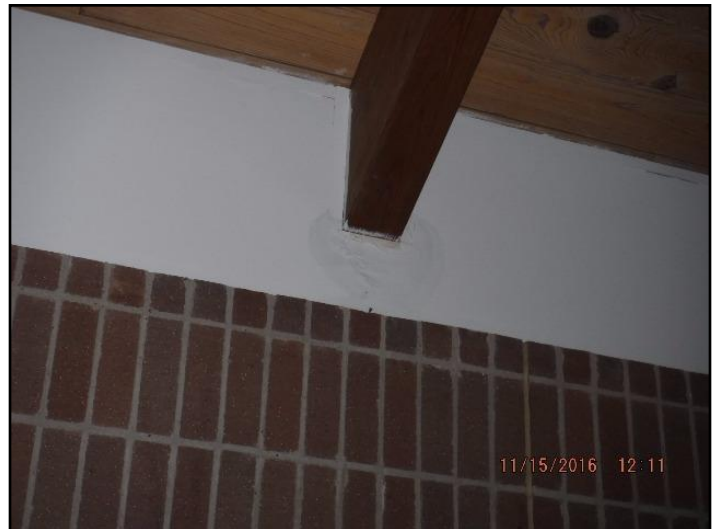
14. **Condition:** • Water damage

Location: Main Fellowship Hall (Chancel Area); Right Rear Storage Closet; Foyer

28. Water damage

Task: Further evaluation

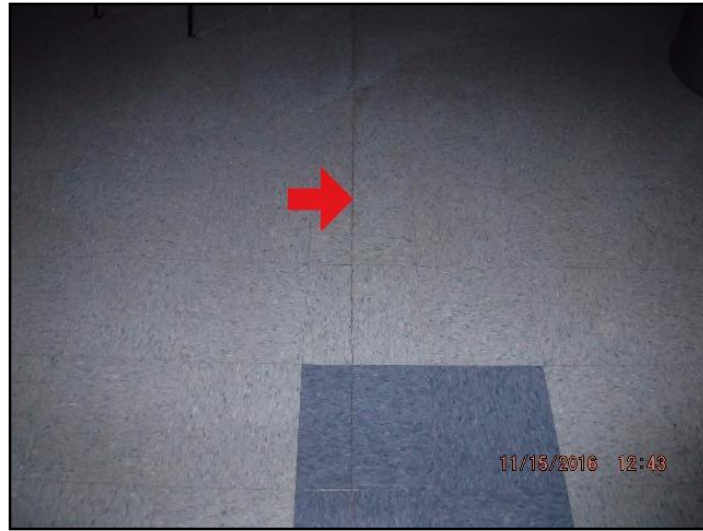
Cracks in resilient tile

Location: Main Fellowship Hall

34. *Damaged*

Task: Repair or replace

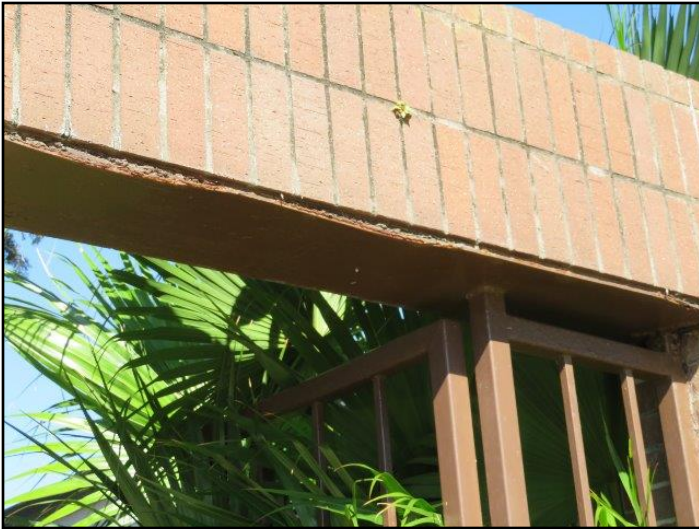
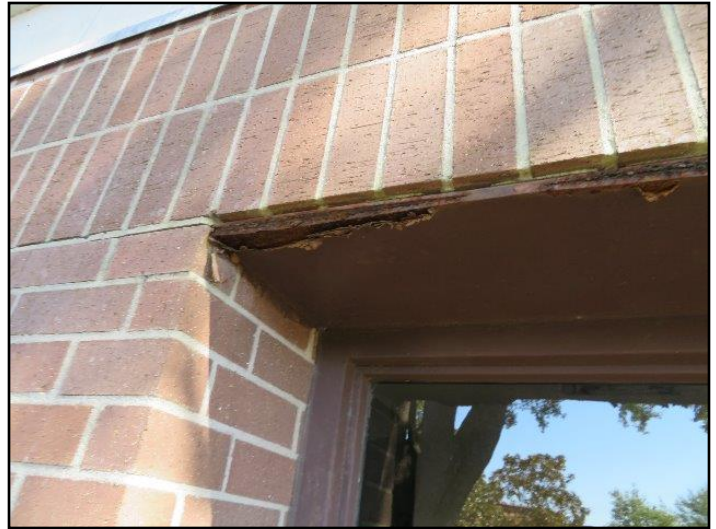
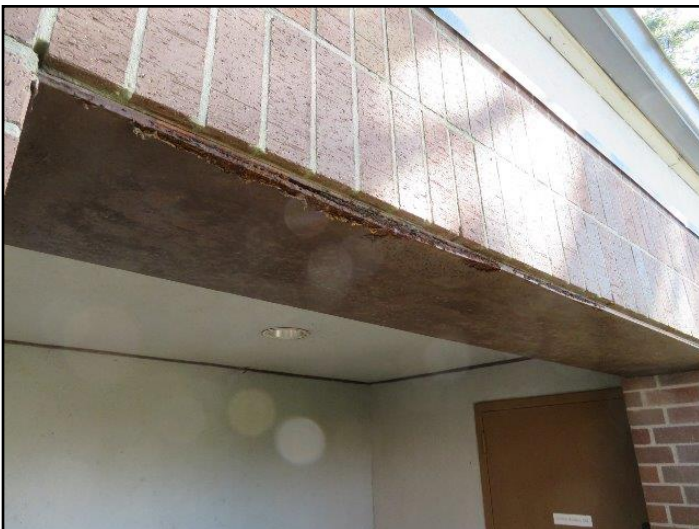
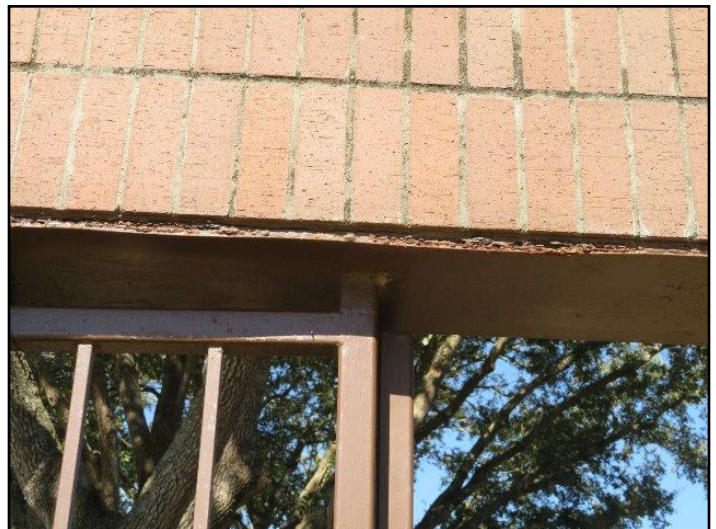
17. Condition: • Numerous metal lintels are badly rusted and are causing minor deflection of brick veneer.

Task: Evaluate and remedy as needed.

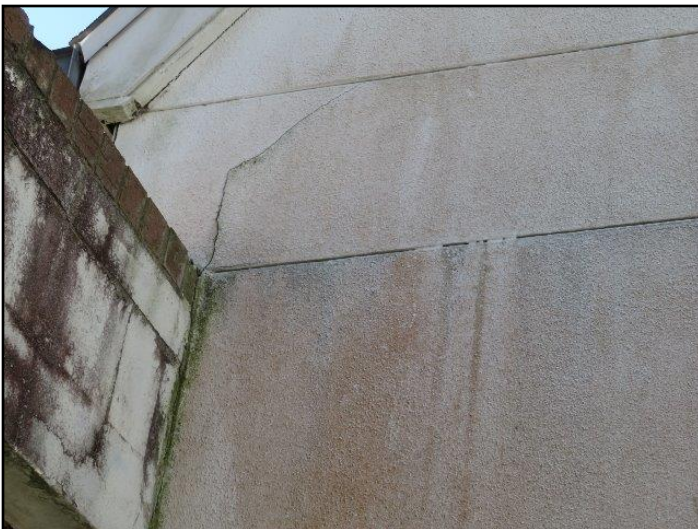
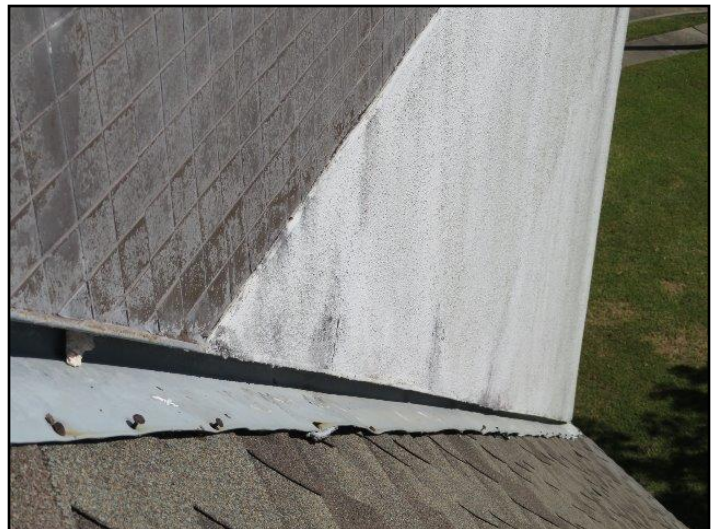
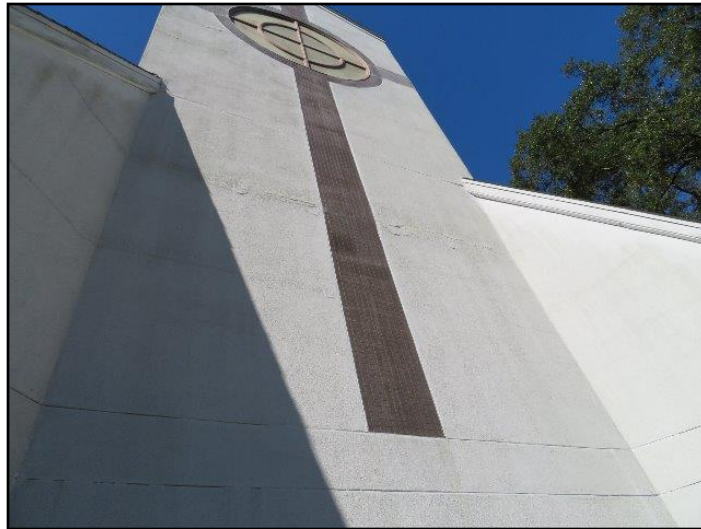
19. Condition: • Many areas of upper and lower exterior walls are badly faded and cracked.

Task: Seal and recoat as needed.

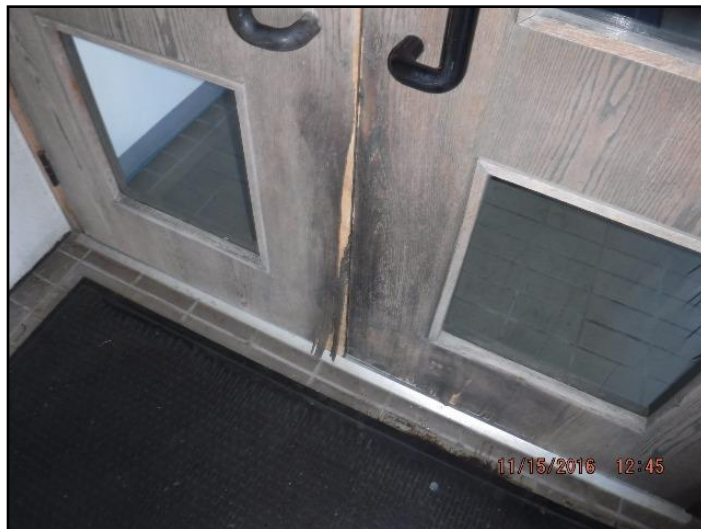
20. Condition: • De-laminated/weathered door face

Location: Front Entrance

44. *De-laminated/weathered door face*

Task: Repair or replace

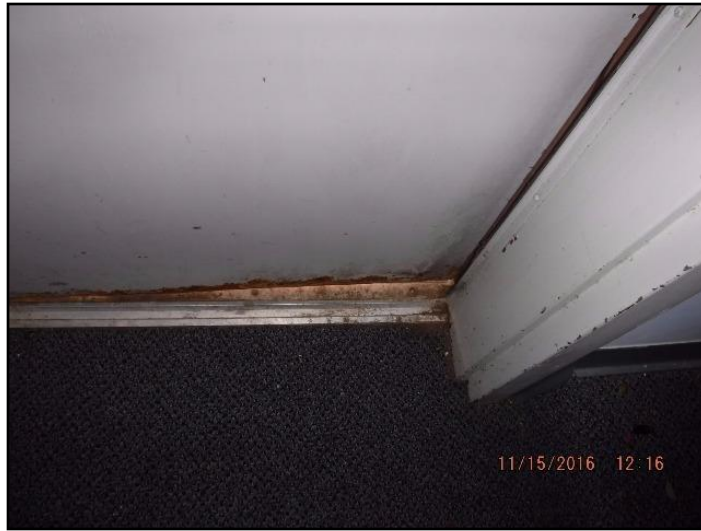
21. Condition: • Corroded

Location: Rear Right Exit Door

45. Corroded

Task: Repair or replace

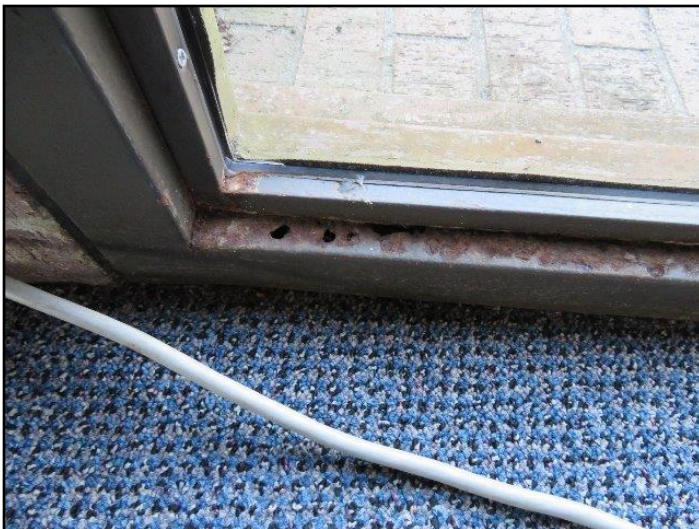
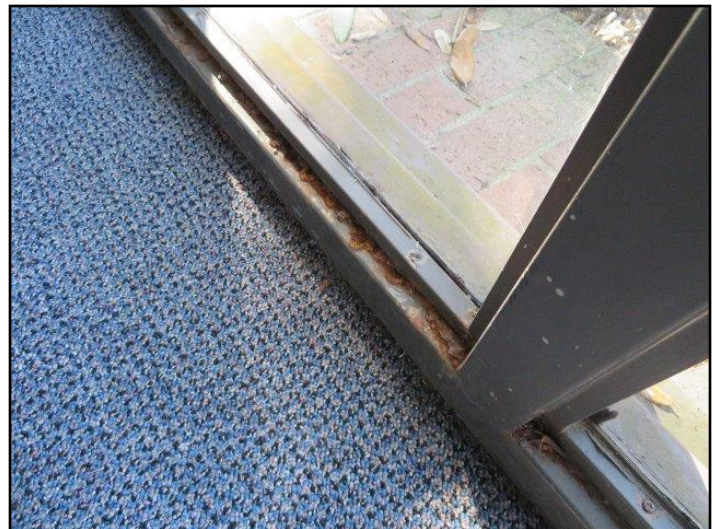
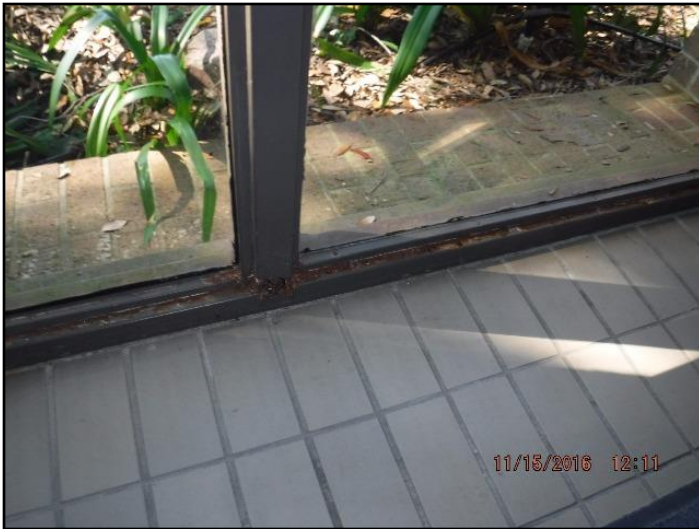
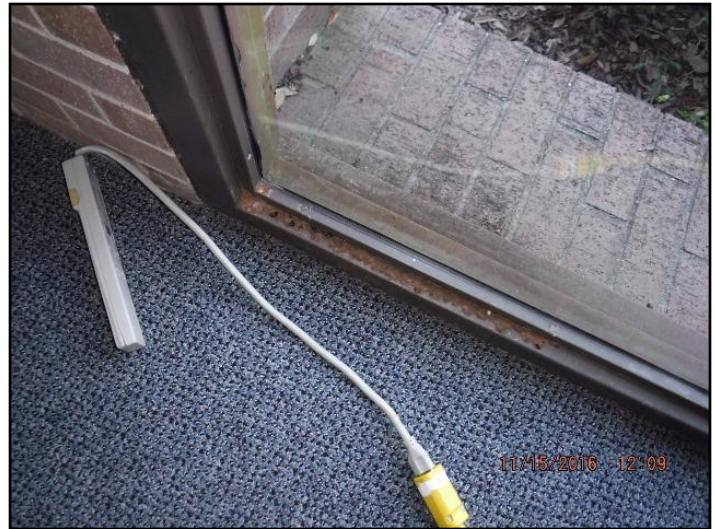
22. Condition: • Rusted/pitted window frames

Location: Foyer

48. Rusted/pitted window frames

Task: Repair or replace

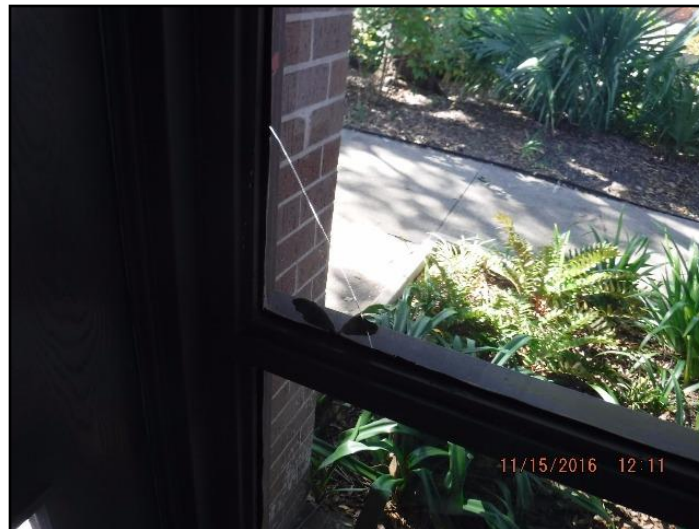
23. Condition: • Cracked pane

Location: Foyer

50. Cracked pane

Task: Replace

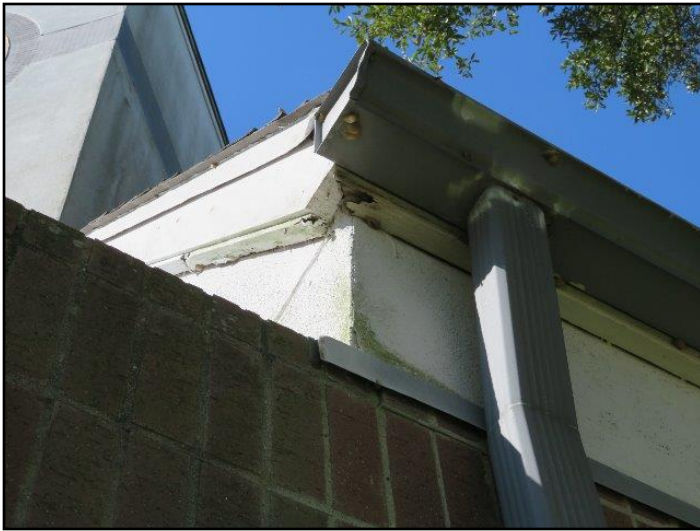
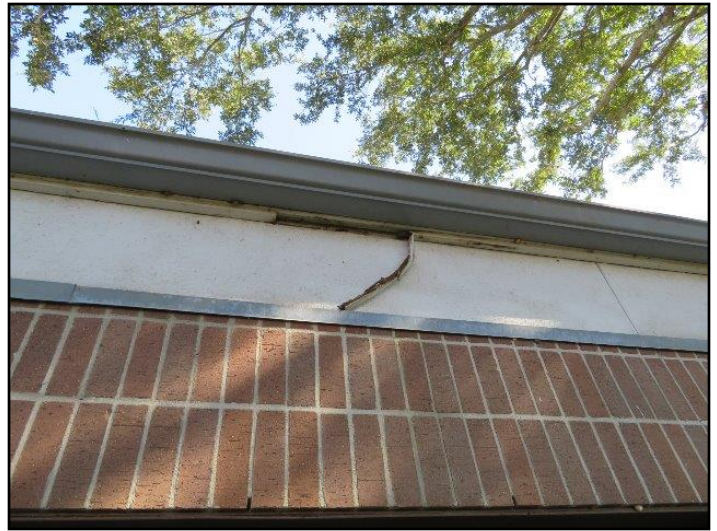
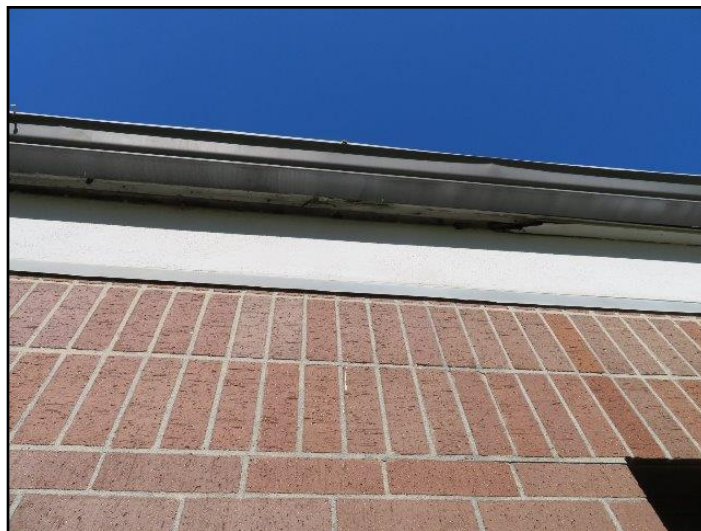
24. Condition: • Wooden drip edge is missing and rotted in numerous locations. Should be repaired when roof is replaced.

Task: Repair/replacement should be deferred until roof is replaced.
