YOUR Inspection Report

201 NASA Parkwy, Sanctuary, Suite Sanctuary
Webster, TX 77598

RE: Report No. 1089
201 NASA Parkwy, Sanctuary, Sanctuary
Webster, TX
77598

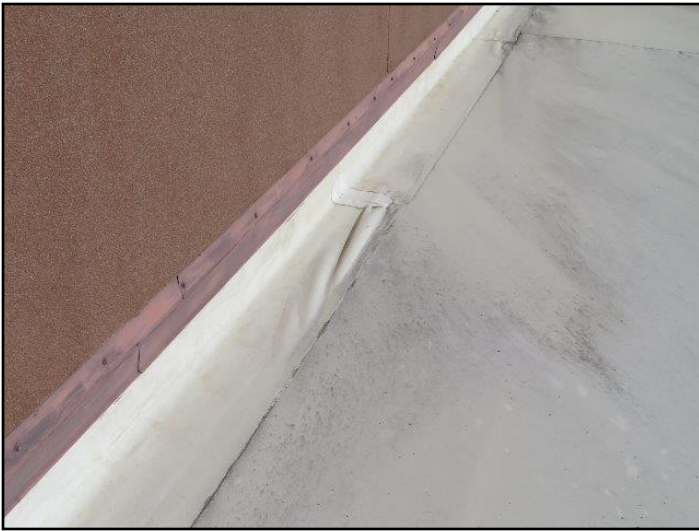
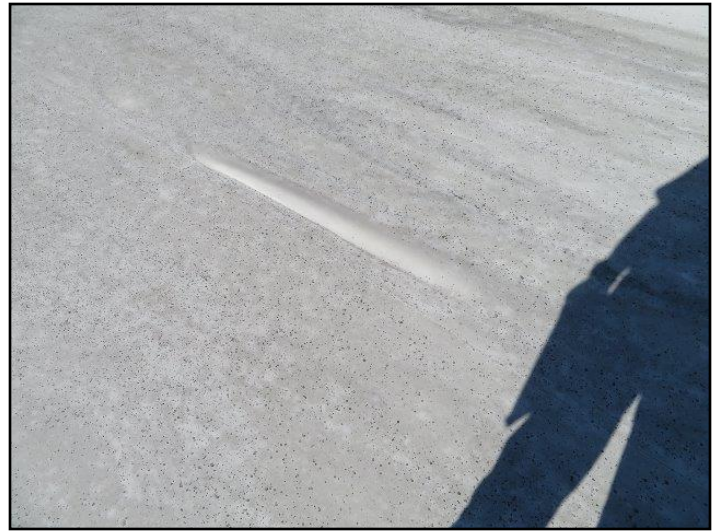
Condition: • Small sections of blistering were observed.

10. Condition: • Small sections of blistering were observed.

Task: Monitor and remedy as needed.

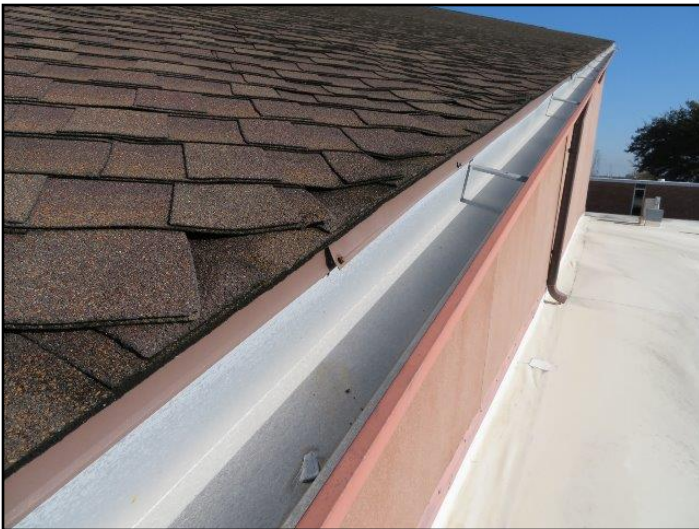
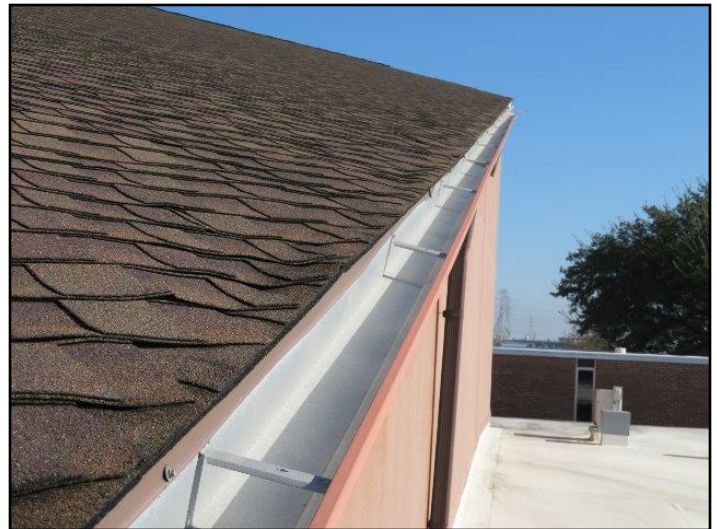
Condition: • Cupping or deflection of shingles and decking was observed.

Location: Along main perimeter edges.

12. **Condition:** • Cupping or deflection of shingles and decking was observed.

Task: Monitor for leaking. When roof is replaced these areas will probably require new decking which will add cost to re-roof.

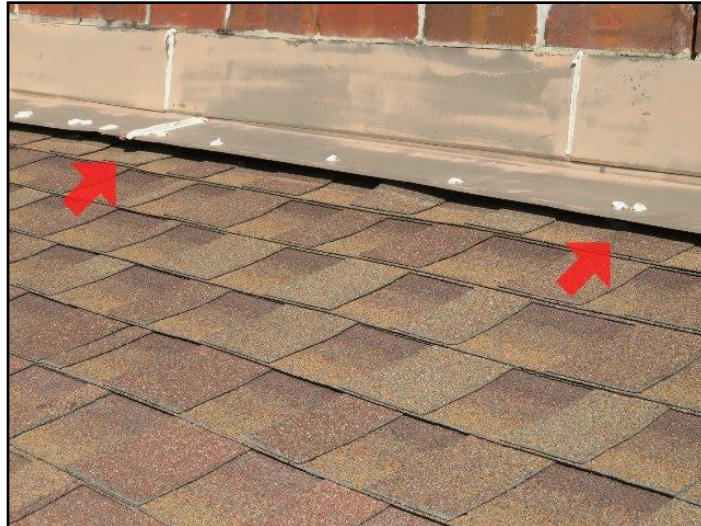
26.

Condition: • Base flashing is lifted.

Location: Right edge at base of upper small wall and main roof deck at front of sanctuary over large stained glass windows.

14. Condition: • Base flashing is lifted.

Task: Seal and secure as needed to prevent moisture penetration.

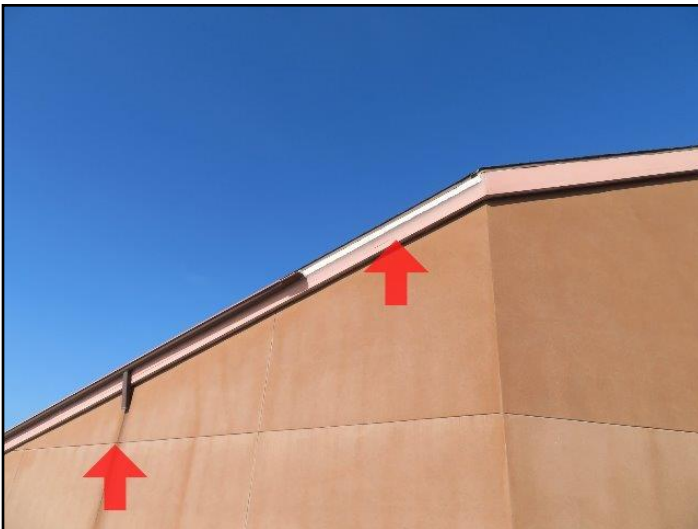
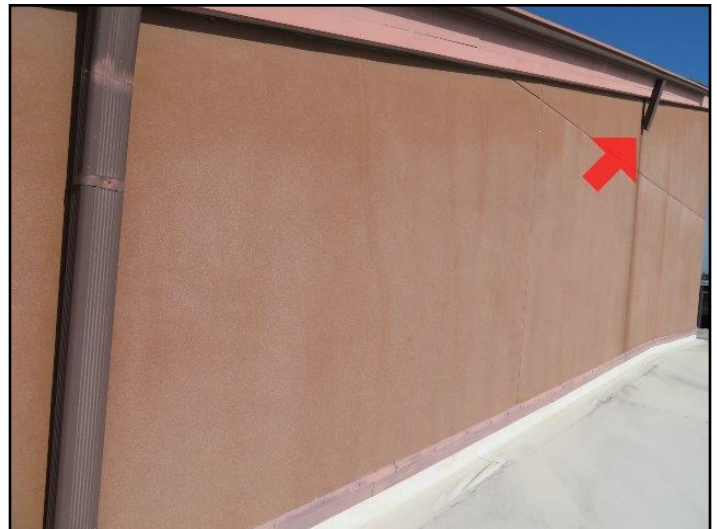
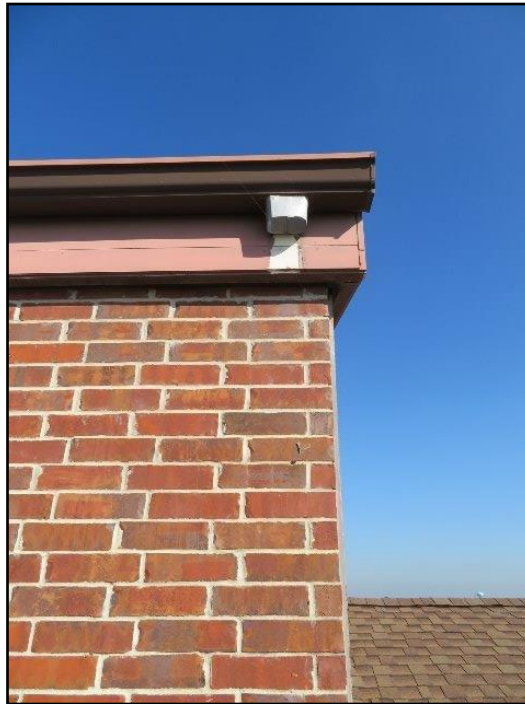
Condition: • Damage and missing gutter and downspouts were observed.

Location: Gutter at back of upper roof and downspouts at upper and lower roof sections.

15. Condition: • Damage and missing gutter and downspouts were observed.

Task: Repair as needed.

Cost: \$1,500 - \$2,000

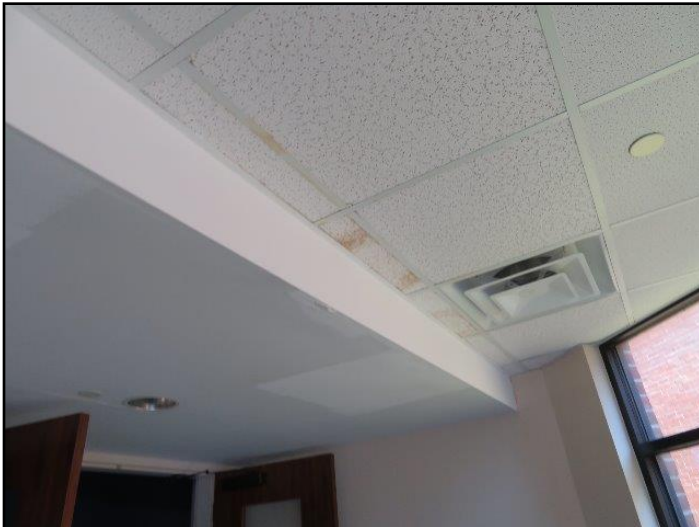
17. Condition: • Water damage

Drywall and ceiling tiles.

Location: Entry into main sanctuary.

30. Water damage

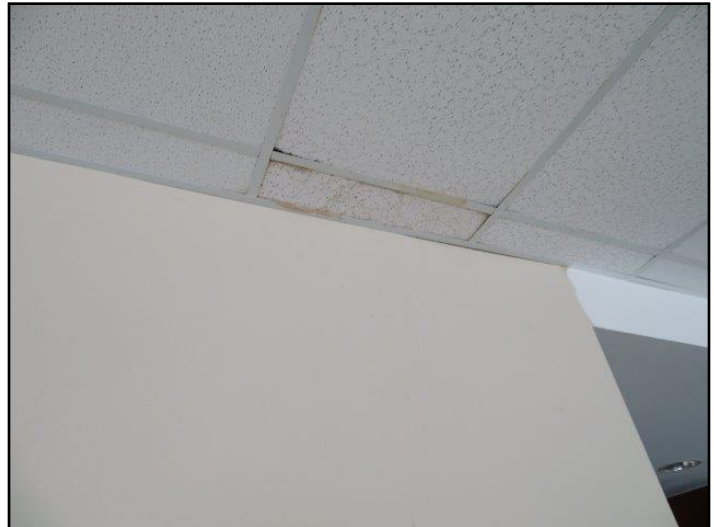
31. Water damage

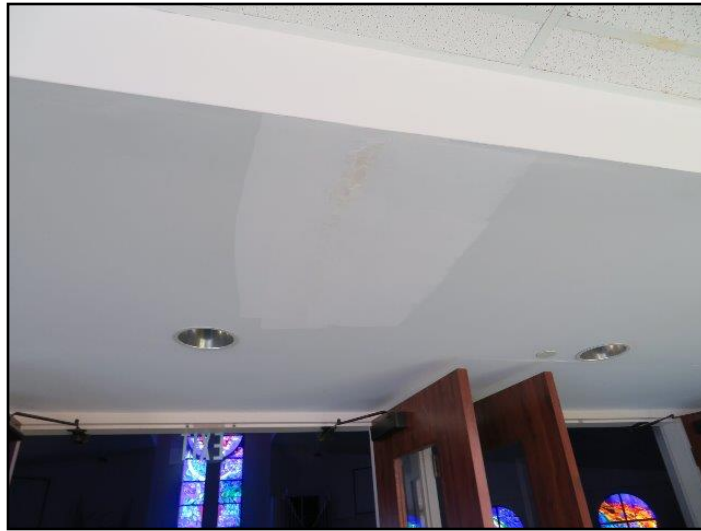
32. *Water damage*

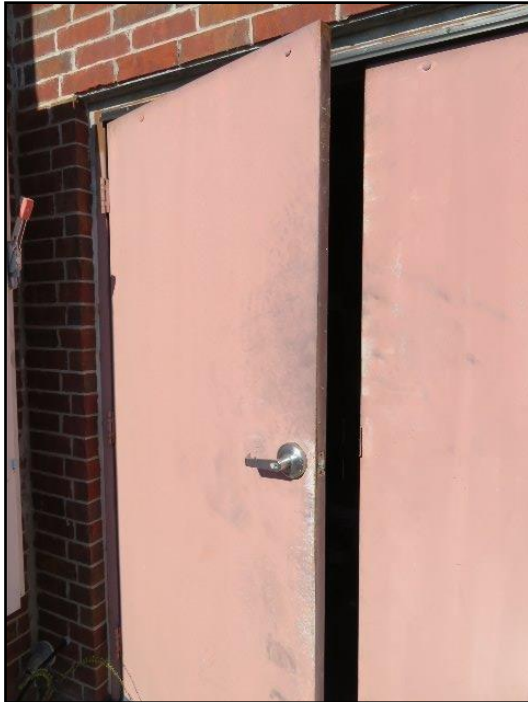
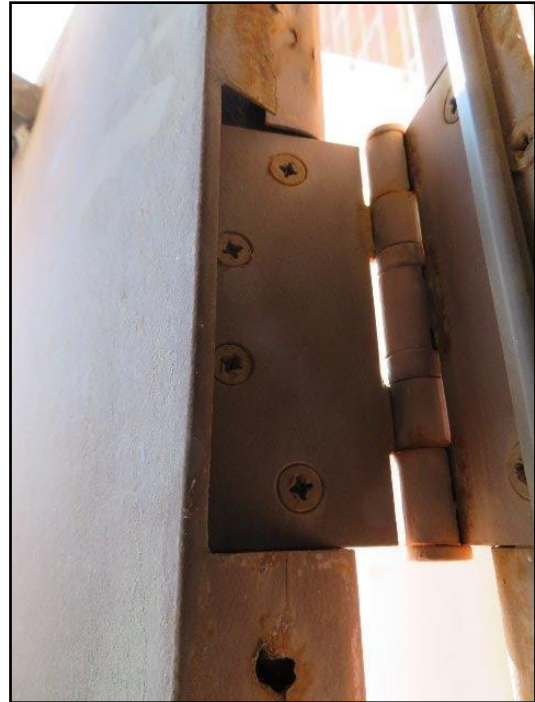
• Mechanical roof door is not closing properly. Could be rusted out.

20. • Mechanical roof door is not closing properly. Could be rusted out.

Location: Entry to HVAC equipment.

Task: Evaluate and remedy as needed to ensure proper operation.

Cost: Replacement: \$1,000-\$1,500

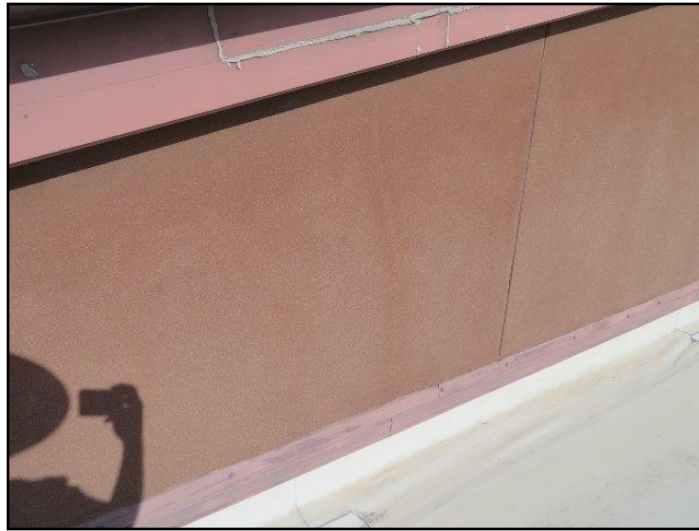
36.

Condition: • Cracking was observed in numerous sections.

22. Condition: • Cracking was observed in numerous sections.

Location: Upper wall over lower roof and lower wall sections.

Task: Properly seal and coat walls is recommended.

Cost: \$3.50-\$4.00 linear foot.
