August 4, 2014

Webster Presbyterian Church
201 W NASA Parkway
Webster 77598
Attn: Melisa Ferguson

**RE: LIMITED MOLD INSPECTION AND SAMPLING FOR AIRBORNE MOLD SPORES -
WEBSTER PRESBYTERIAN CHURCH**

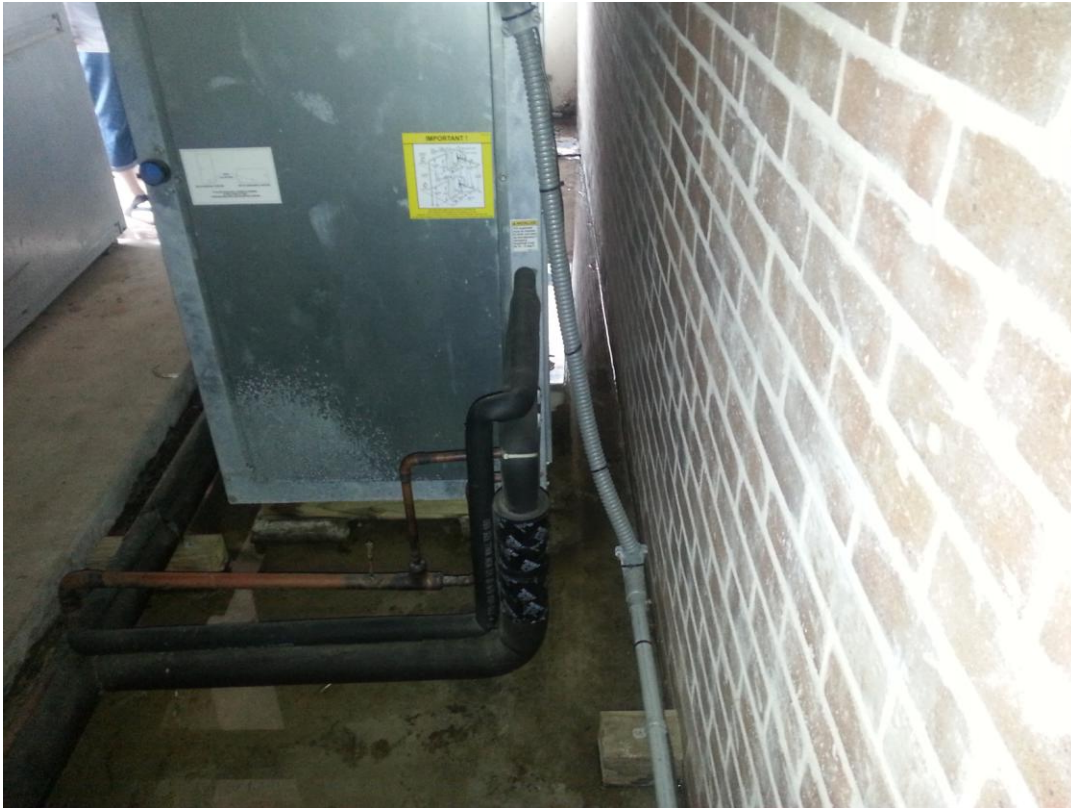
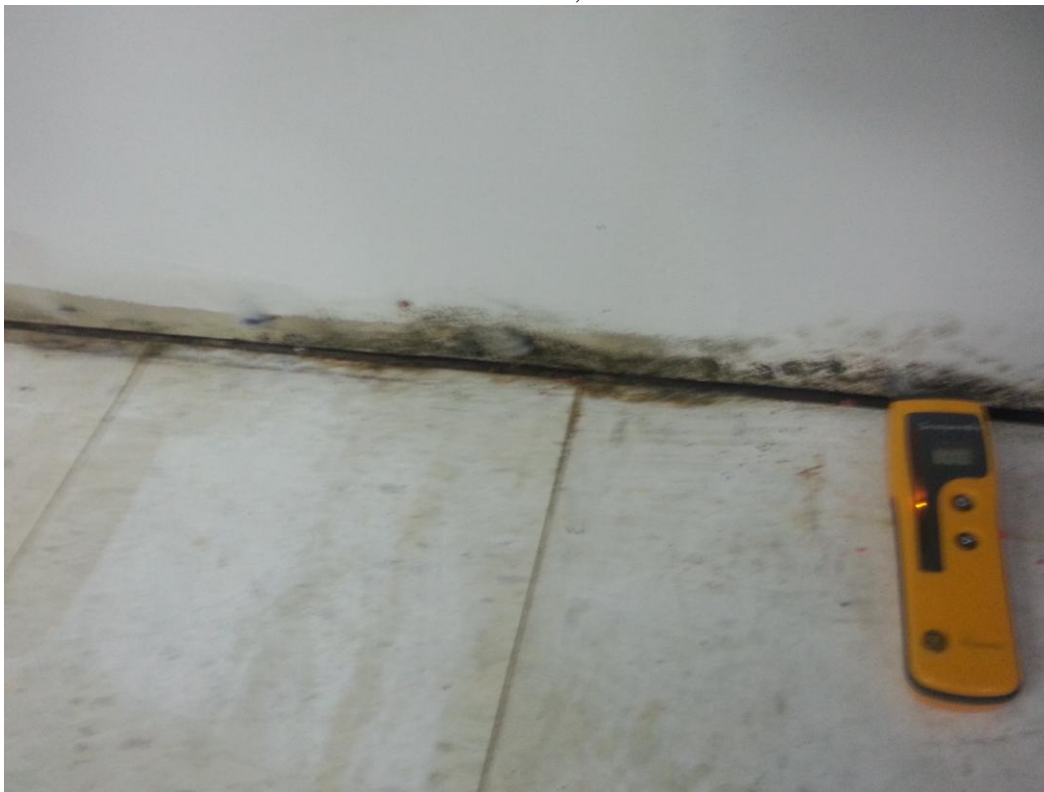
1st floor classroom area - a small area of visible mold growth was present on the base of the wall separating the classroom from the HVAC room. At the time of the inspection the moisture level in the sheetrock at the base of the wall was about 15%, slightly elevated above normal but not at the level considered wet and capable of supporting mold growth, about 21%. Water was present on the floor of the HVAC room, possibly from the rain on the previous night. The water intrusion probably has occurred repeatedly and is the moisture source that allowed the mold growth on the adjoining sheetrock wall.

Standing water on floor of HVAC room, wall with mold is on other side of the brick wall, visible mold on base of wall in classroom, moisture about 17%

The total area of mold growth is about 2 square feet, well under the 25 square feet that is the minimum regulatory limit under Texas law. The maintenance personnel can apply diluted bleach to the area and, when dry, paint with KILZ or a similar stain blocking primer.

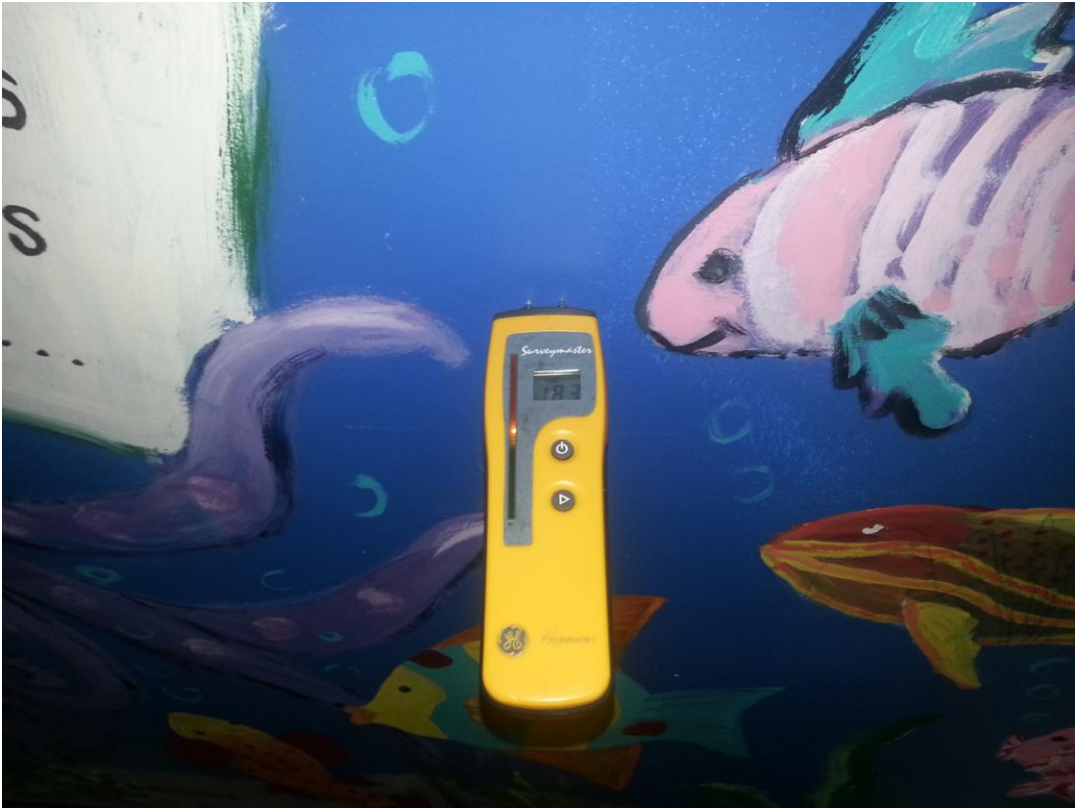
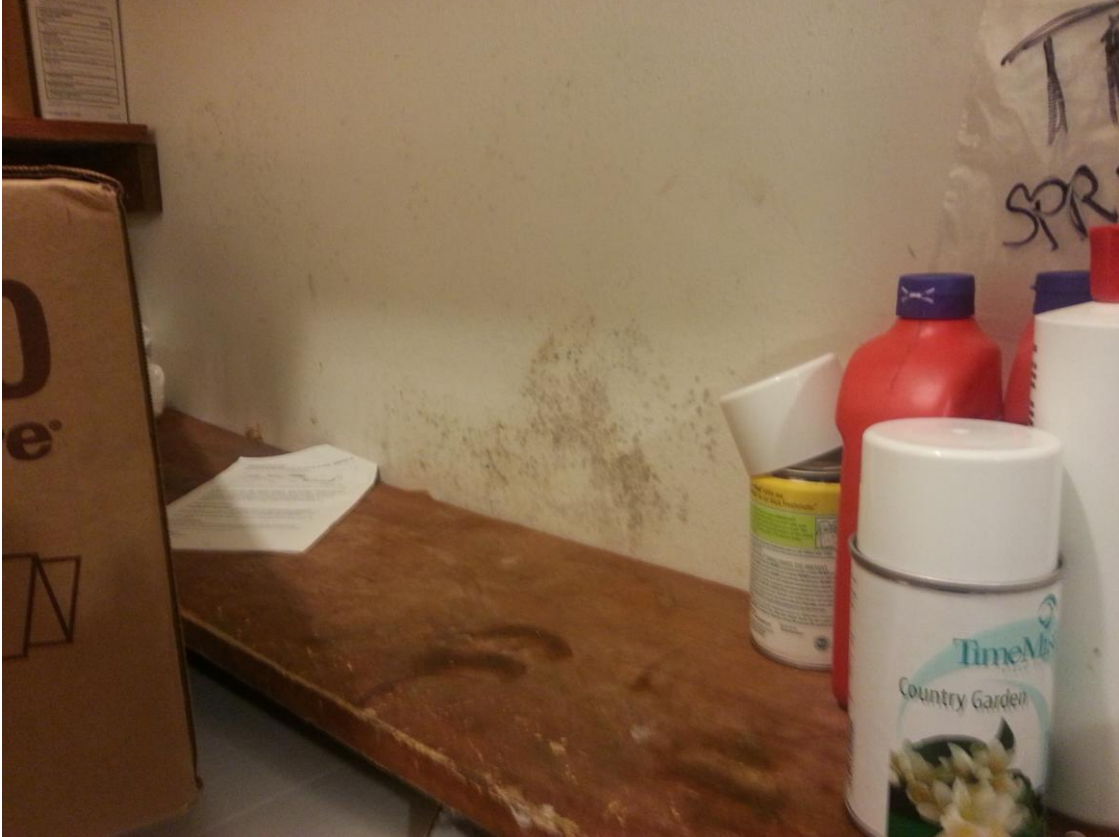
It was reported that previous mold growth has been seen on the exterior walls when something is placed over them, such as a picture. This is caused by moisture traveling through the exterior brick wall and through the void space where it is then absorbed by the sheetrock. The moisture is drawn into the living space through the sheetrock. As long as the wall surface is not obstructed then the moisture evaporates.

A small area of mold was seen on the wall in the janitor's closet. It was less than 1 square foot in size. There was no obvious moisture source but there is a faucet used to fill mop buckets. The mold can be cleaned with bleach and painted as previously described.

Moisture level 18% in exterior wall, mold on wall in janitor's closet

Anything placed against the wall surface that impedes the air flow will result in moisture accumulation and mold growth at that location. No pictures, posters, maps or similar can be placed on the exterior walls anywhere in the building. Furniture can be placed near the wall as long as a few inches of clearance is maintained.

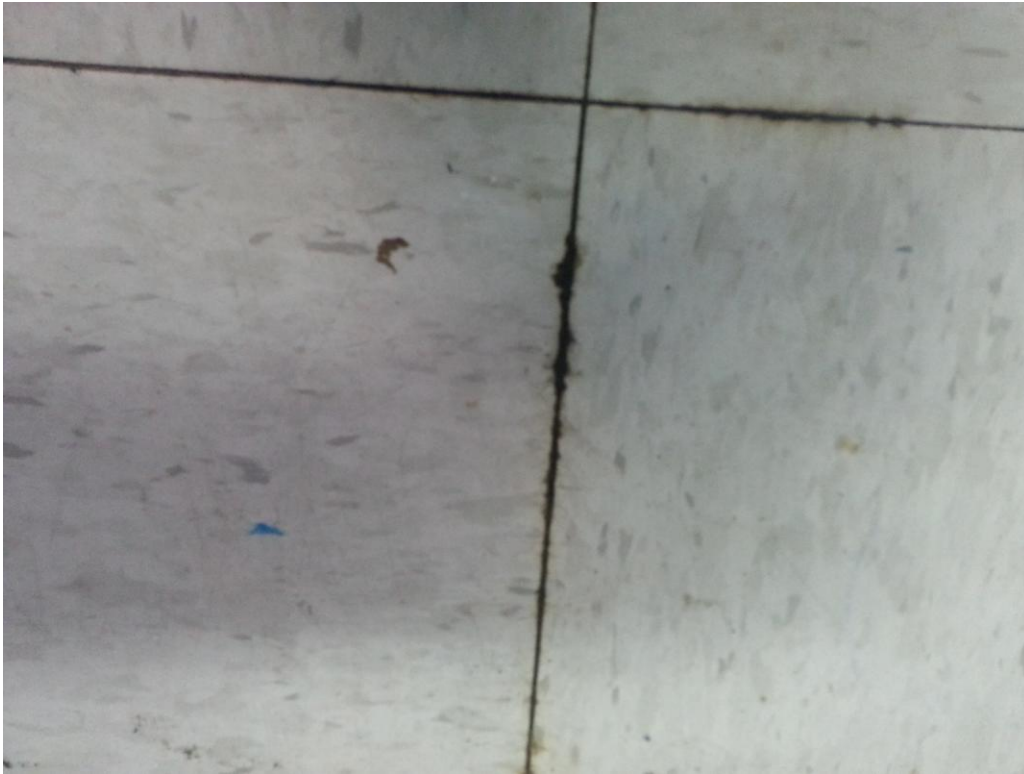
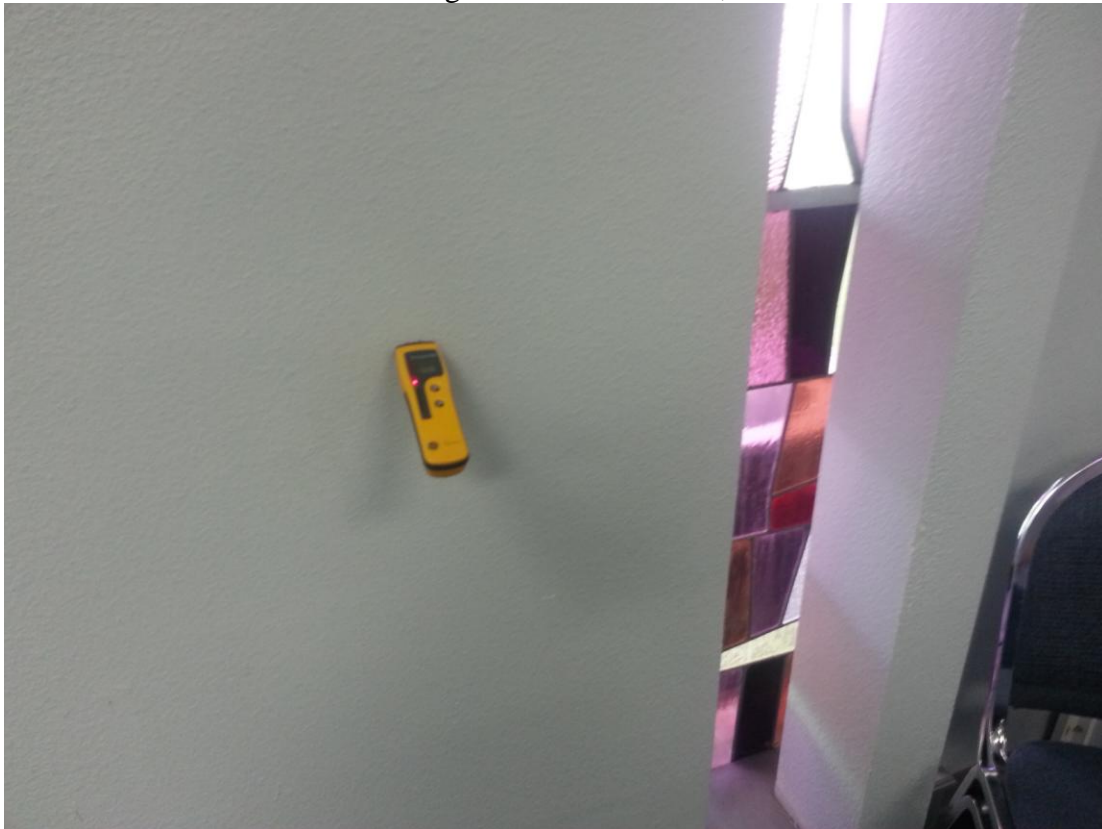
Concern was also expressed about an accumulation of dark staining around seams of the vinyl floor tiles. This is not mold but is caused by moisture coming through the slab and dissolving the glue used to attach the tiles to the cement. The water and dissolved glue travels to the edges of the tiles and up, where it dries and deposits the glue. There are also accumulations of material on the tiles that appears to be mineral deposits that may be related to evaporation of the water coming up through the floor. These are not mold.

An area of elevated moisture was found in a front building near the offices. There is an active roof leak above a stained glass window. The area to the left of the window had moisture of 20% and greater over an area about 3' wide. At the time of the inspection there was no visible water damage or mold growth.

Black material on floor tiles is dissolved glue from underneath, elevated moisture bedside window
